CONSTRUCTION STORMWATER GENERAL PERMIT INSPECTION REPORT

State of Washington Department of Ecology

The Electron Hydro LLC Intake project is covered under the State of Washington's Construction Stormwater General Permit (CSWGP). The CSWGP is a National Pollutant Discharge Elimination System (NPDES) and a State Waste Discharge permit for discharge of construction-related stormwater. Carol Serdar had previously been to the site a few years' prior, during the JARPA review for the then proposed construction of the barrier dam and intake structure.

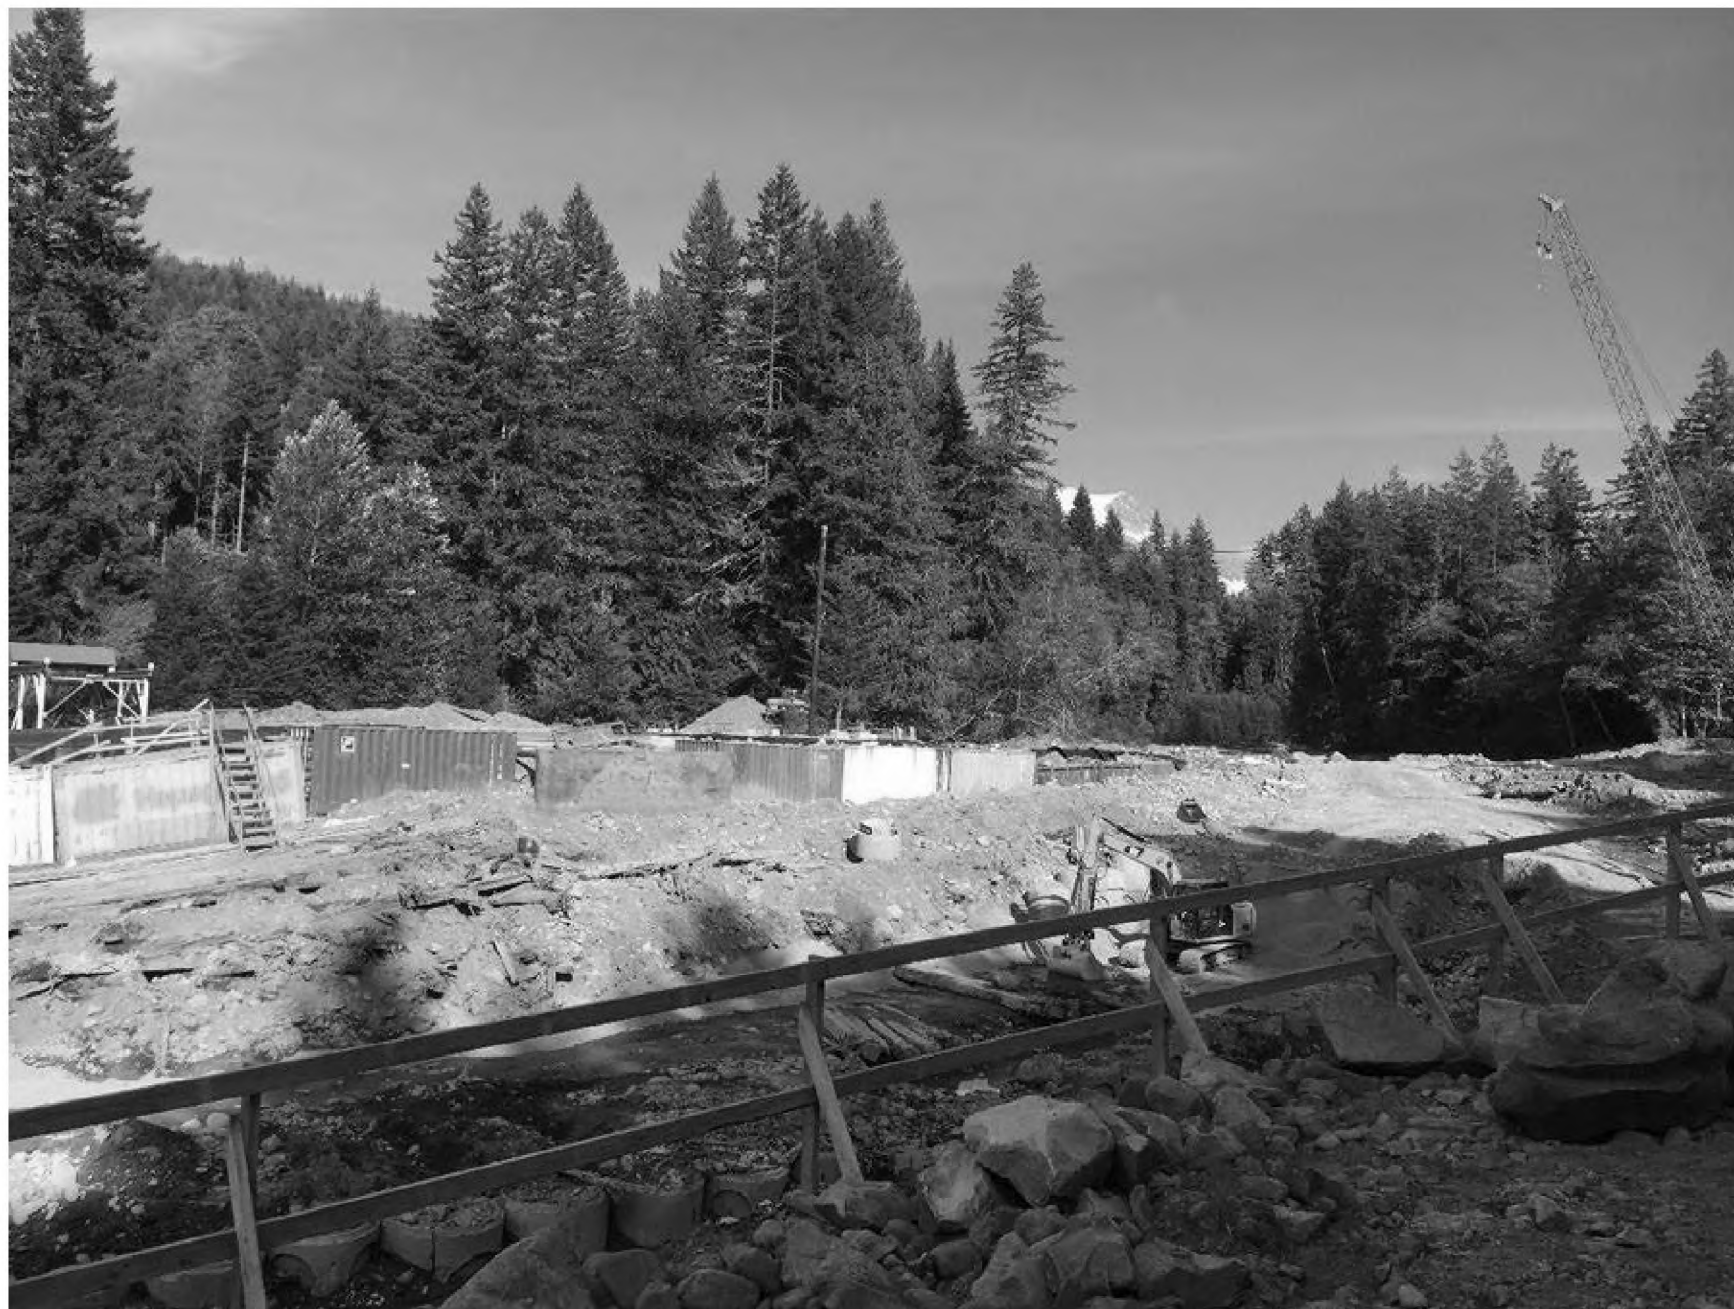
Photo 26

Photo Description: Upstream end of the construction area for the intake structure.

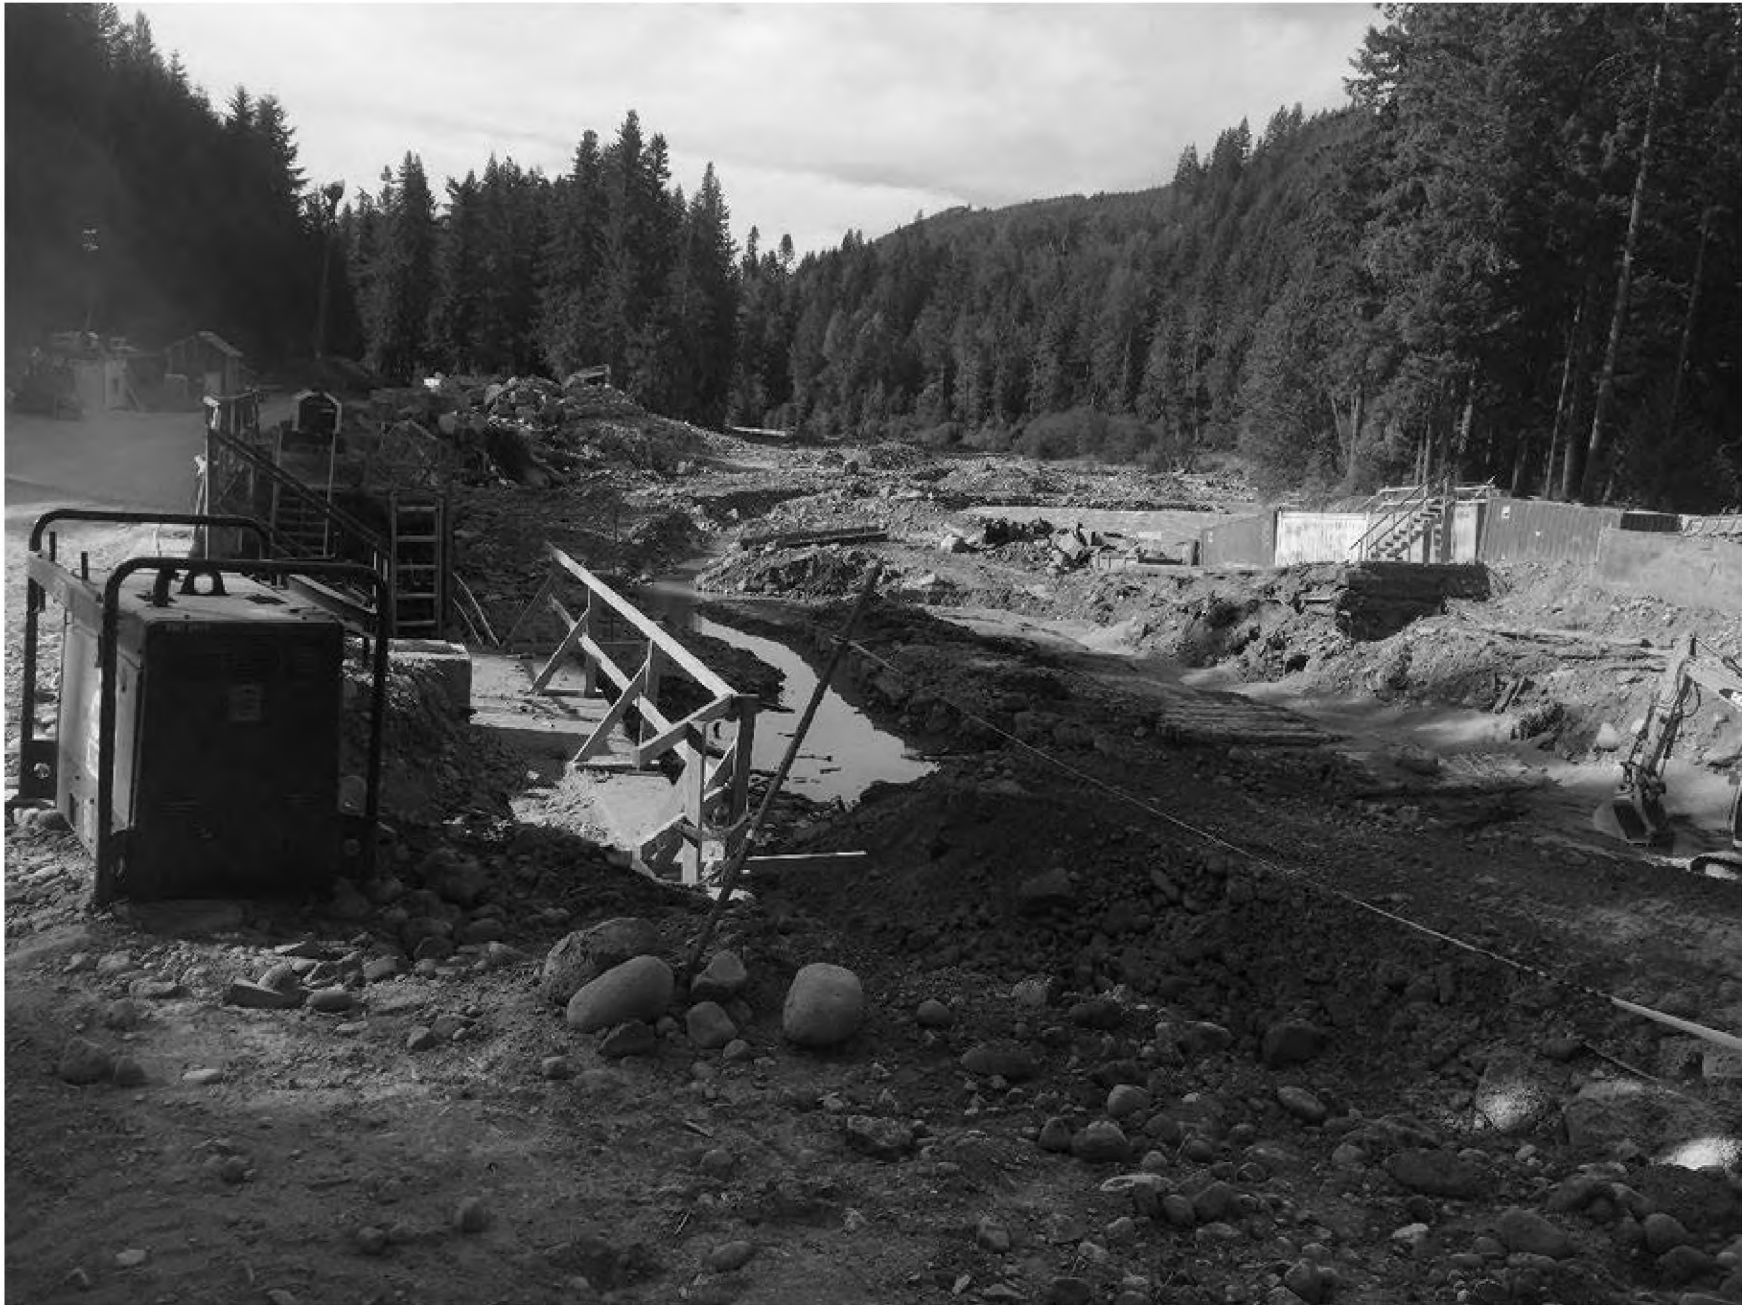
Photo 27

Photo Description: Downstream end of the construction area for the intake structure.

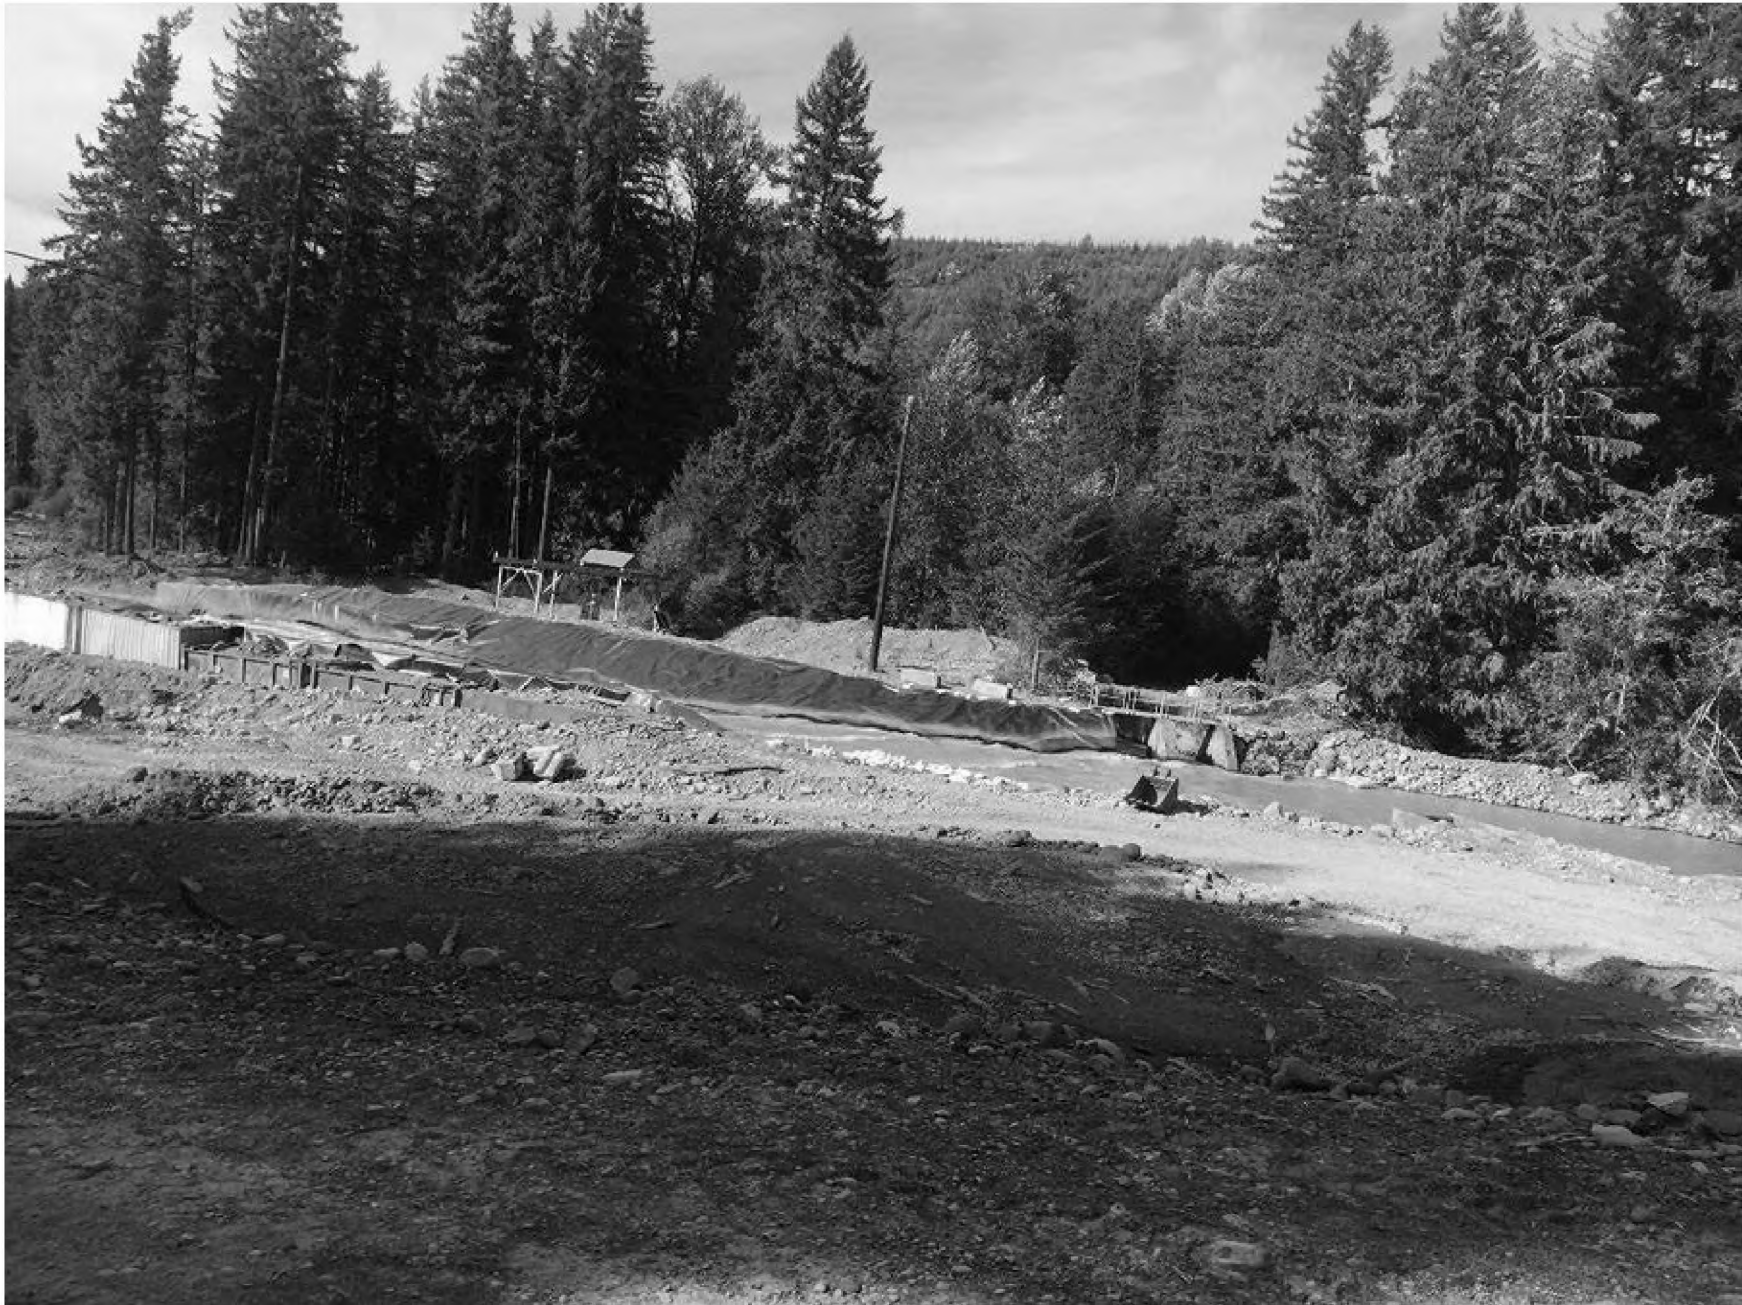
Photo 28

Photo Description: Fish ladder opening to the right of the black liner of the channelized river.

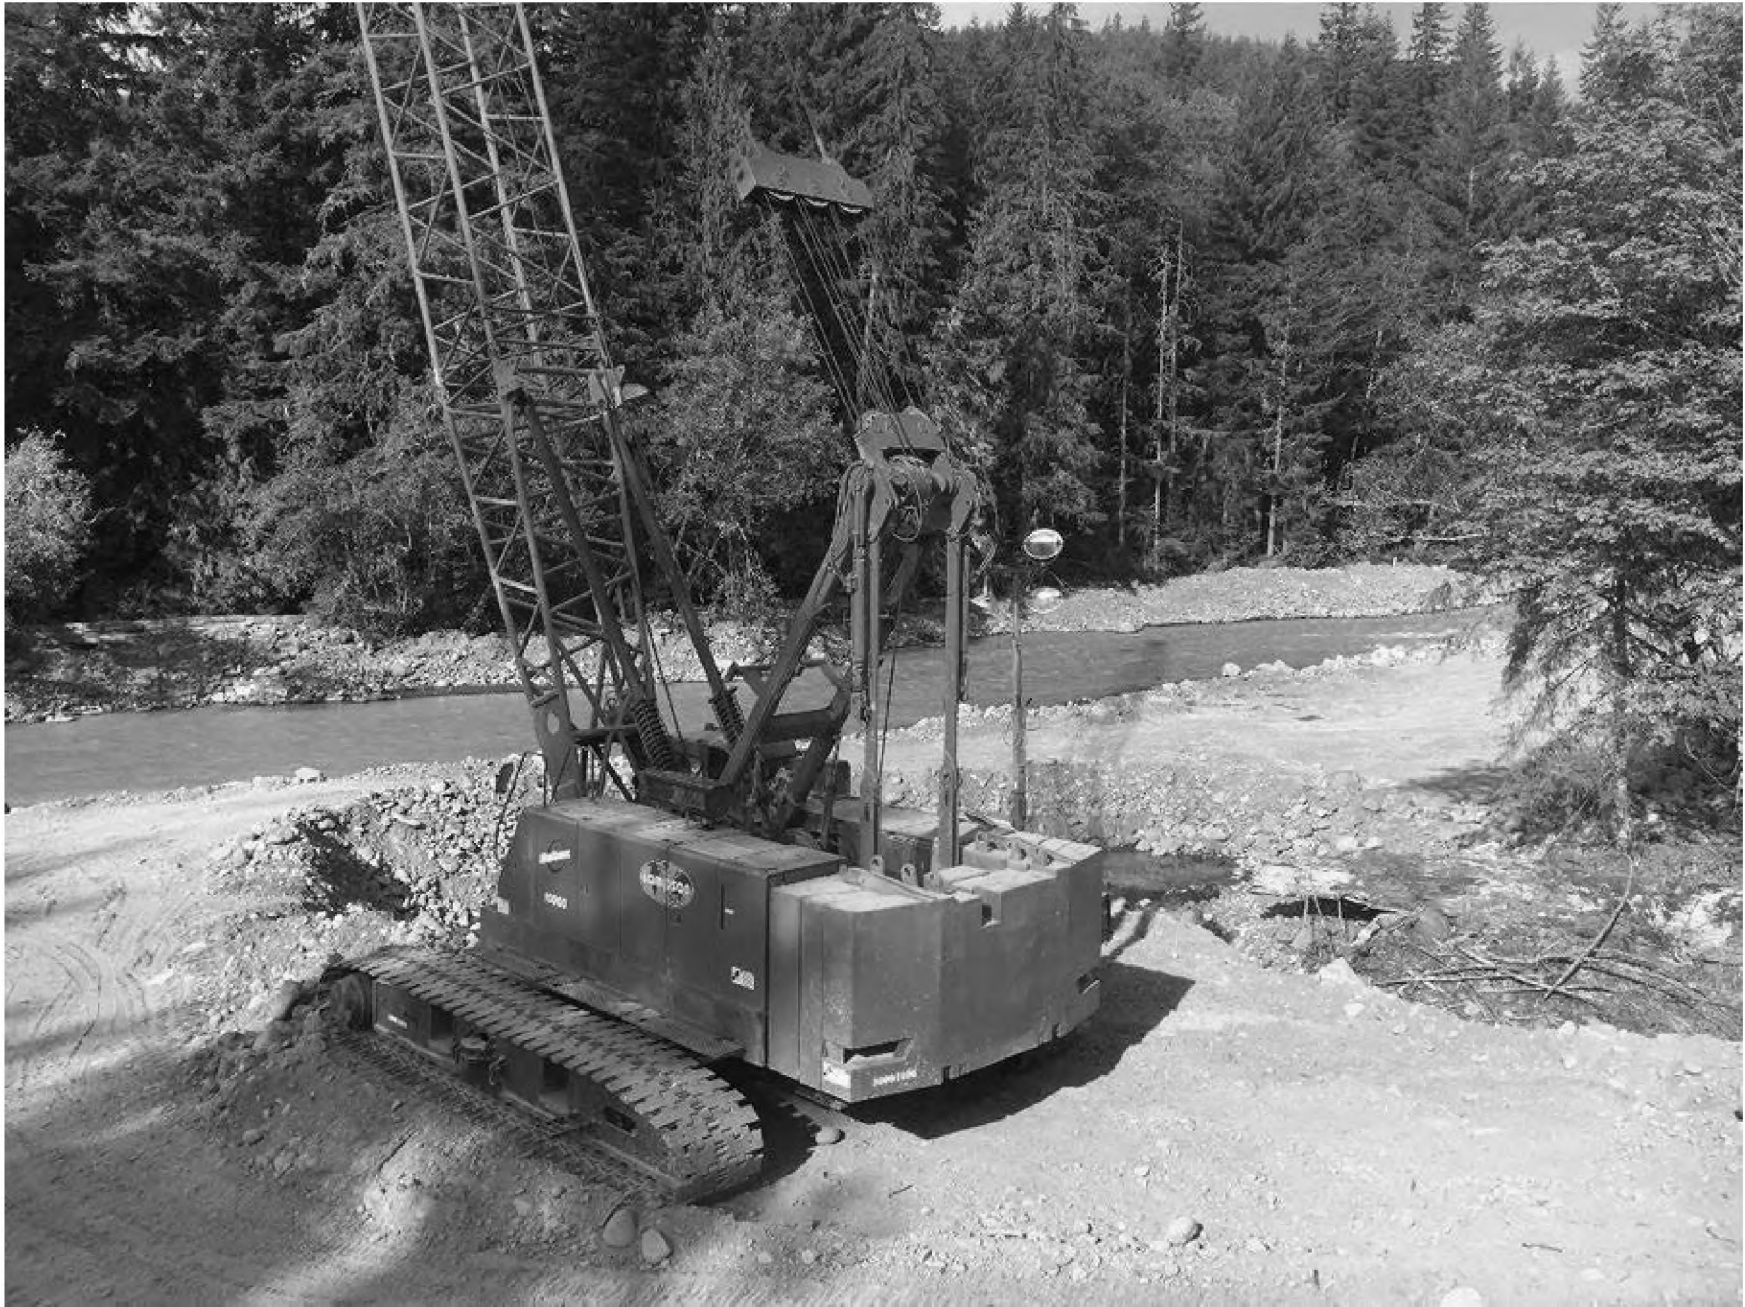
Photo 29

Photo Description: Mostly dry pond on opposite side of the crane. Crane used to move rolls of sports turf to area of placement (below black liner). Berm along the left bank of the Puyallup River is part of the coffer dam setup.

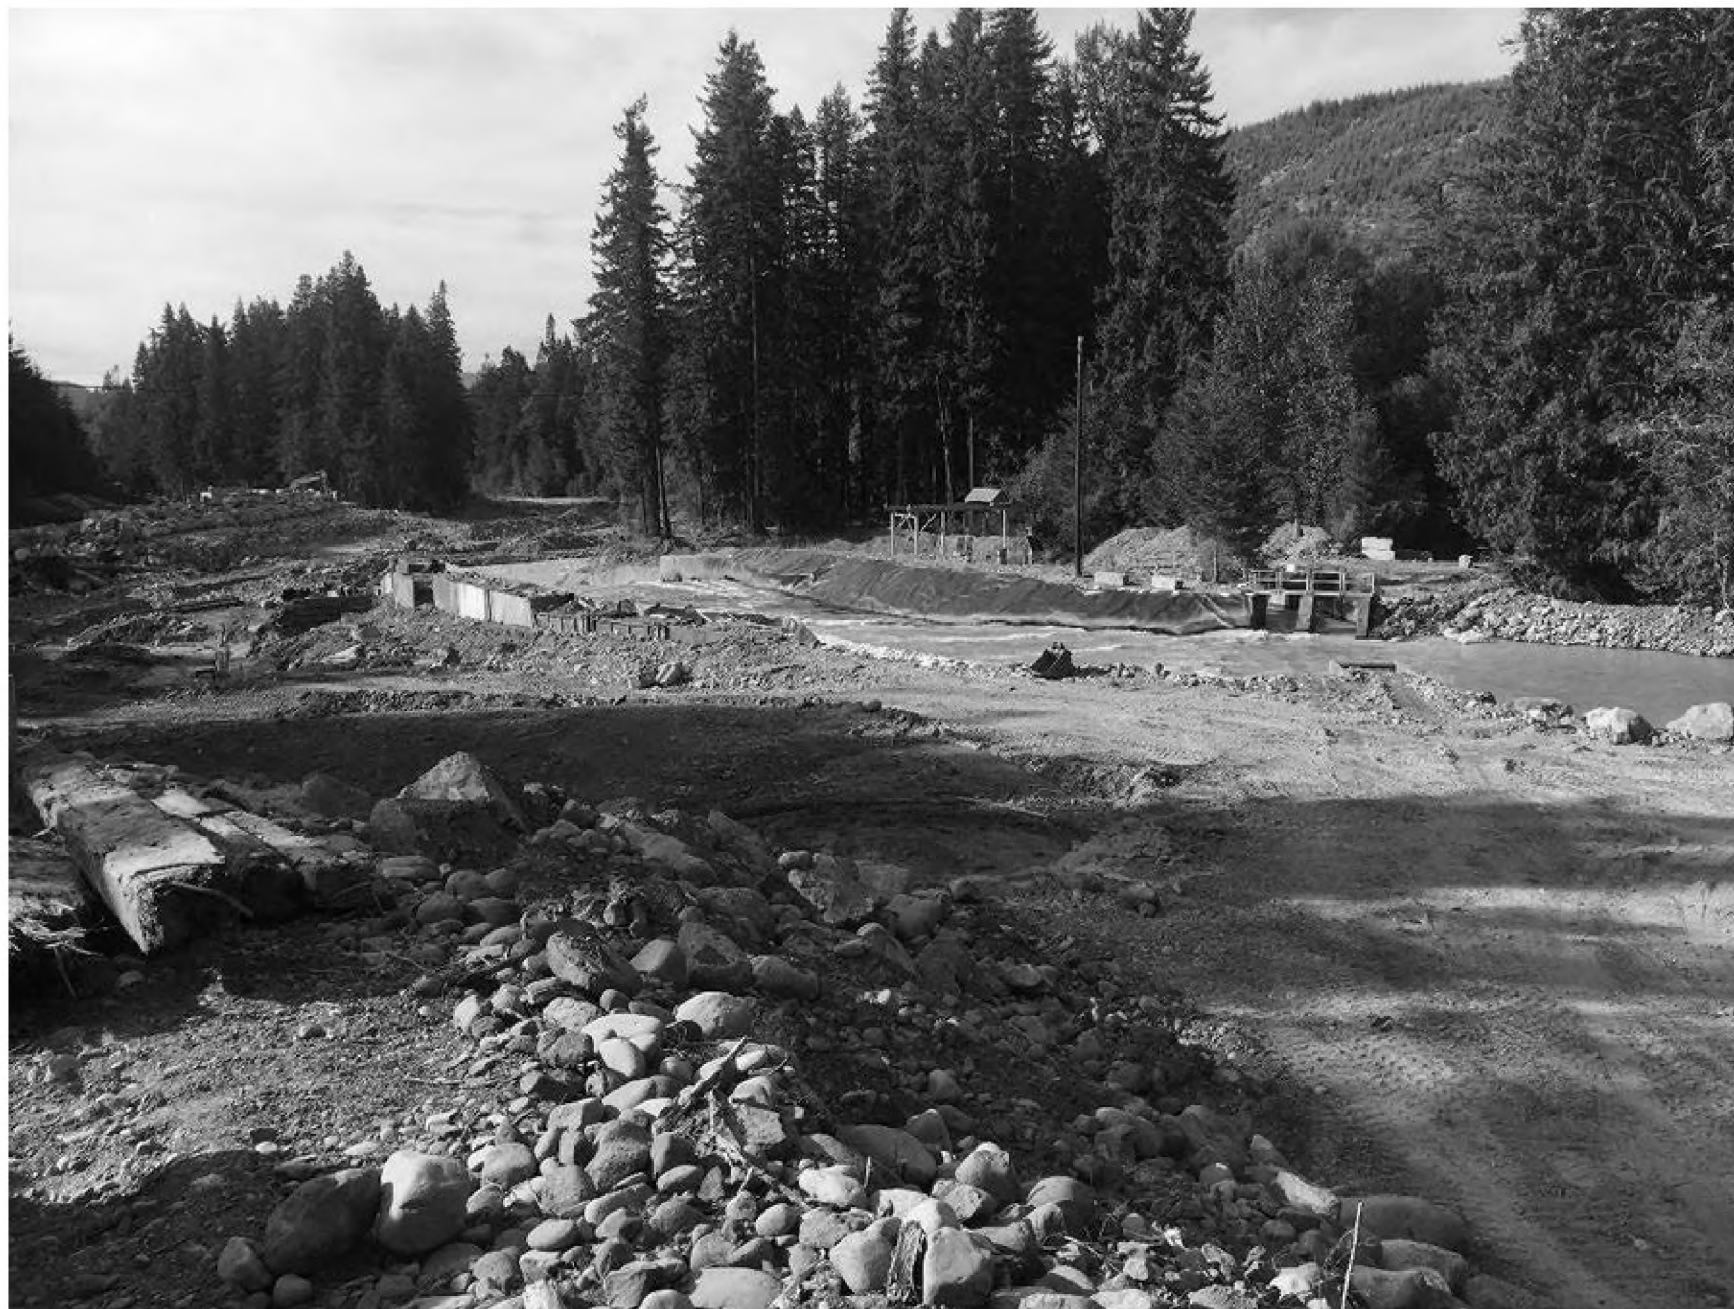
Photo 30

Photo Description: Fish ladder across river from the crane.

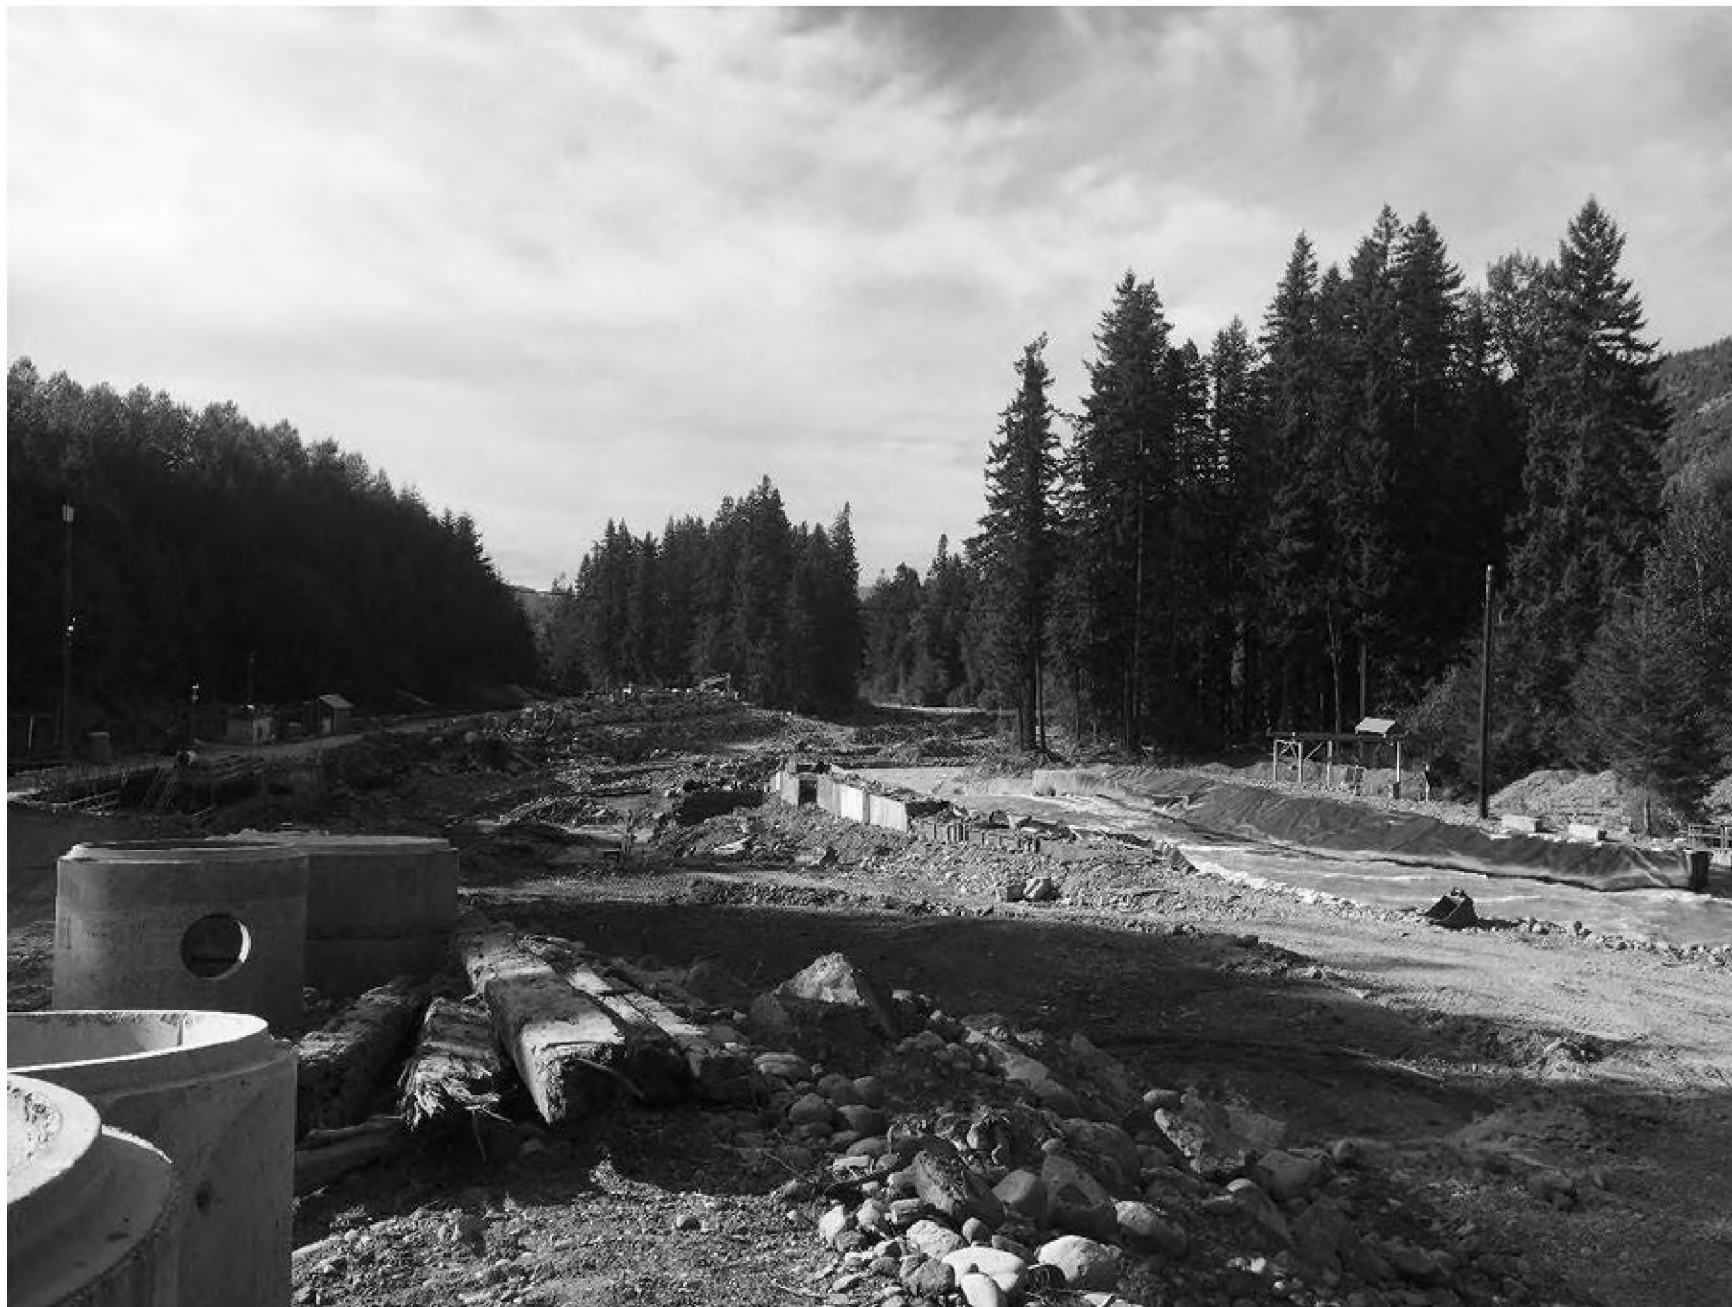
Photo 31

No rubber bits from the sports turf were observed in the area along the big bend in the access/haul road. Thom stated he would have his employees look for and remove any additional black rubber bits from the sports turf and dispose of them properly (garbage bags and brought to an appropriate landfill).

Photo Description: Looking downstream from crane location; this is the area rolls of sports turf was delivered. No black rubber bits were observed on the ground in this location.
